Slipping Dial Cord on 1000 Series Trans-Oceanics

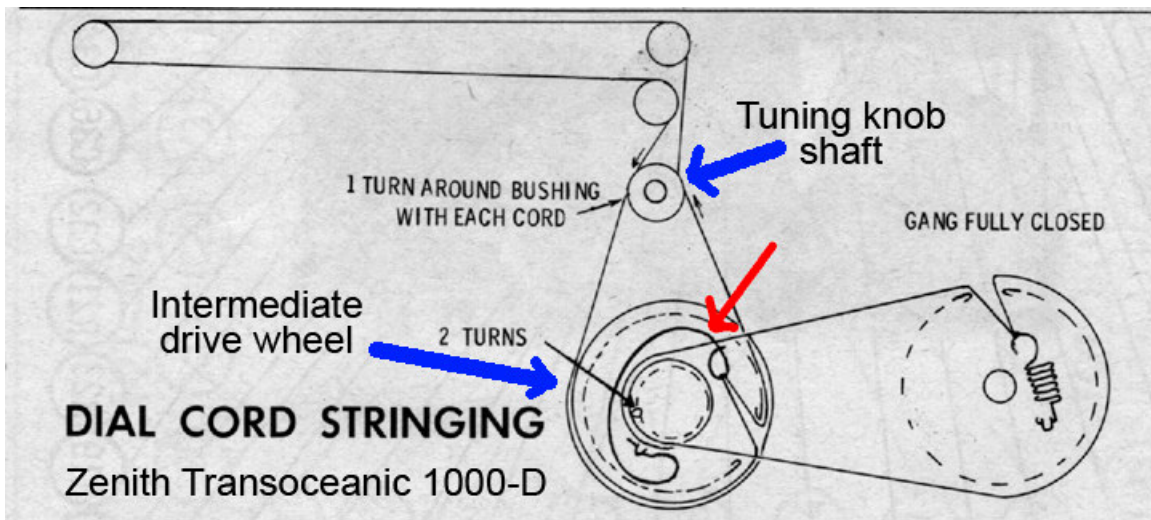
3. If it still doesn't work it will be necessary to remove the chassis re-string the entire dial cord assembly. Refer to the chassis removal link for instructions on chassis removal. The large fishhook (red arrow in diagram below) shaped spring loses tension over the years, and may also need to be slightly bent to re-tension it.
