Zenith Z-1 Model II Battery Instructions

Installing and Replacing the C cell in your Z-1

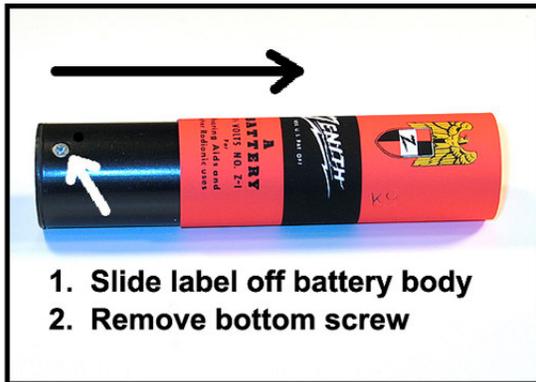
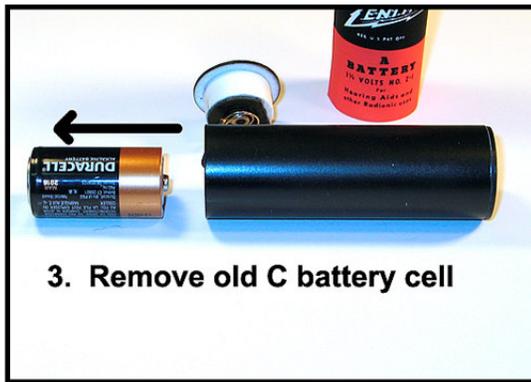
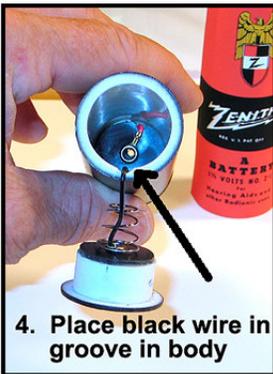
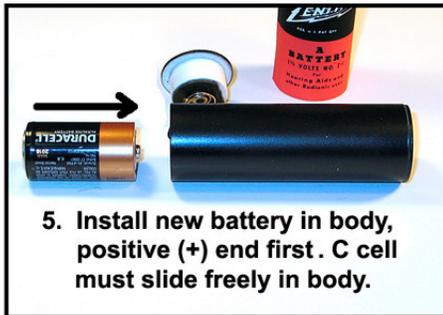
Use a premium quality alkaline C cell for best voltage, longest life, and less chance of leakage. Use of rechargeable cells is not recommended.

1. Install a fresh C cell in the Z-1. See instructions on next page. Insert the connector into the battery, observing proper orientation of the pins. Note that one pin is larger than the other. The large hole is the positive (+) terminal; the small hole is the negative (-) terminal. Insert the connector far enough to make good contact. It does not have to be flush with the top of the battery.
2. If your radio has a holder for the Z-1 battery, ease the battery into the holder, being careful not to scratch or damage the label. On 600 series radios, test to see that the dial light works. On 8G005 radios, if it plays, the installation is successful. If the Z-1 is not providing power, see below.

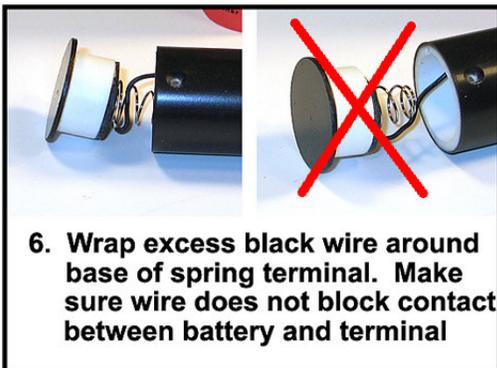
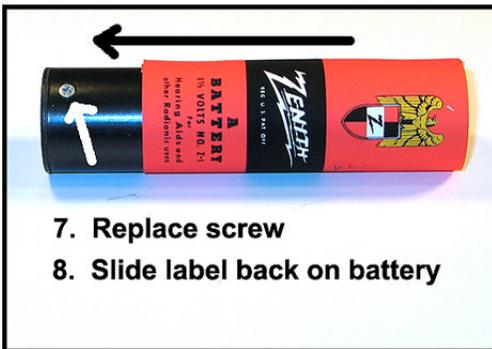
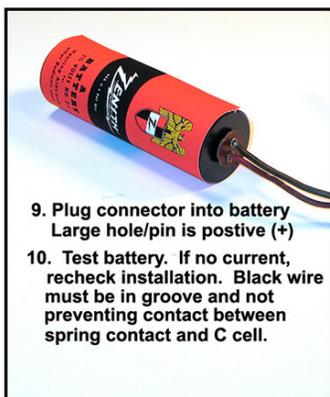
If your battery does not work, see Troubleshooting tips on the previous page. Most often, the problem is incorrect installation of the C cell. Either the battery is not sliding freely in the tube so it can contact the positive terminal or the black wire is blocking contact between the spring and bottom of the C cell.

If the dial light does not work, or your 8G005 does not play with the Z-1 installed, test the battery with a VOM or DVM and make sure there is voltage at the contacts. There should be about 1.6 volts with a fresh C cell. If the battery is providing less than 1.4 volts, replace the battery. If there is no current with a fresh C cell installed, check your C cell installation. The most common problem is a misrouted negative wire. The black wire must be in the groove inside the battery body so that the C cell can move freely inside the tube and be pushed against the positive contact by the negative spring contact. Make sure that the black wire is wrapped around the base of the spring contact, and not blocking contact between the spring and the bottom of the C cell.
